Trinity River Authority of Texas
Enriching the Trinity basin as a resource for Texans

LiDAR Acquisition and Flow Assessment for the Middle Trinity River

October 7, 2015

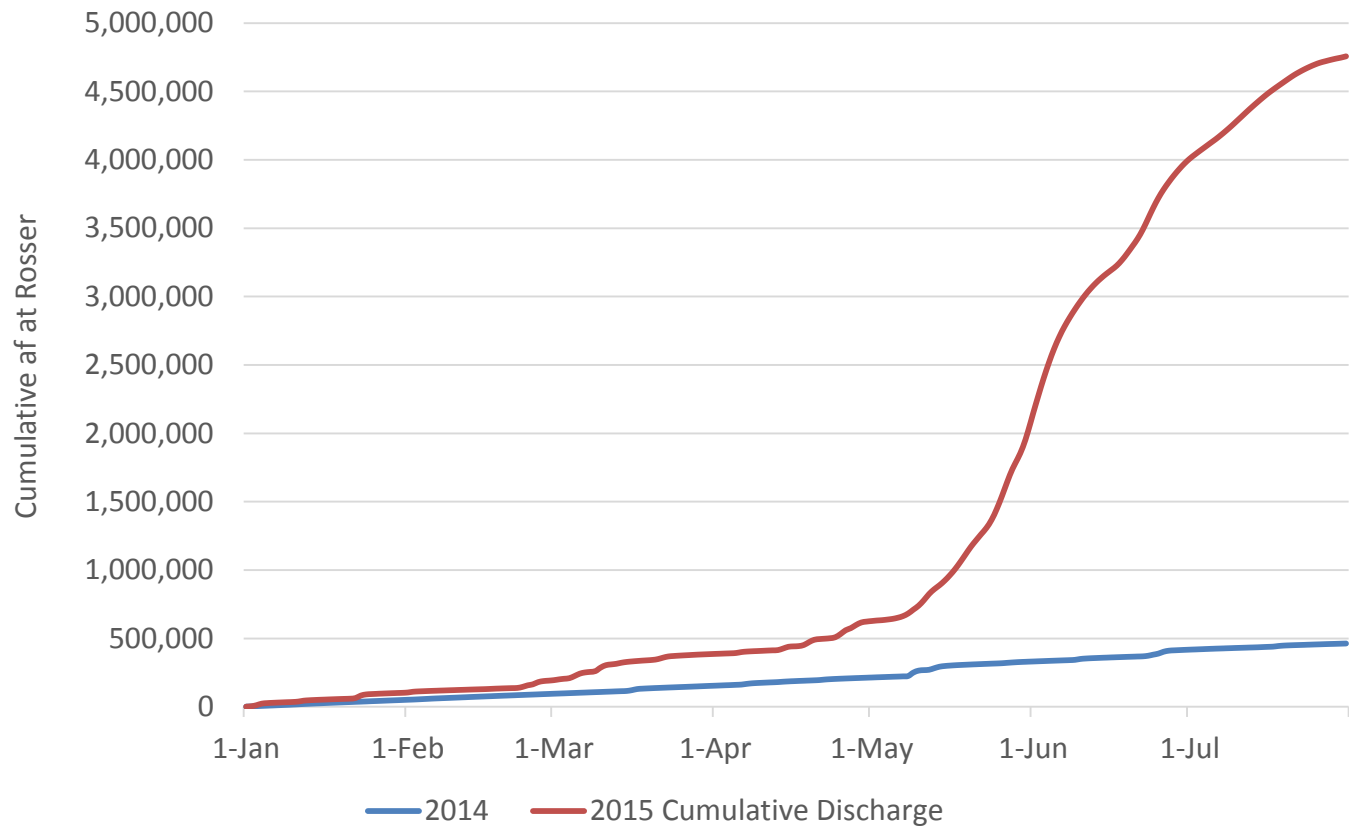
Discharge at Rosser, 2014 vs. 2015

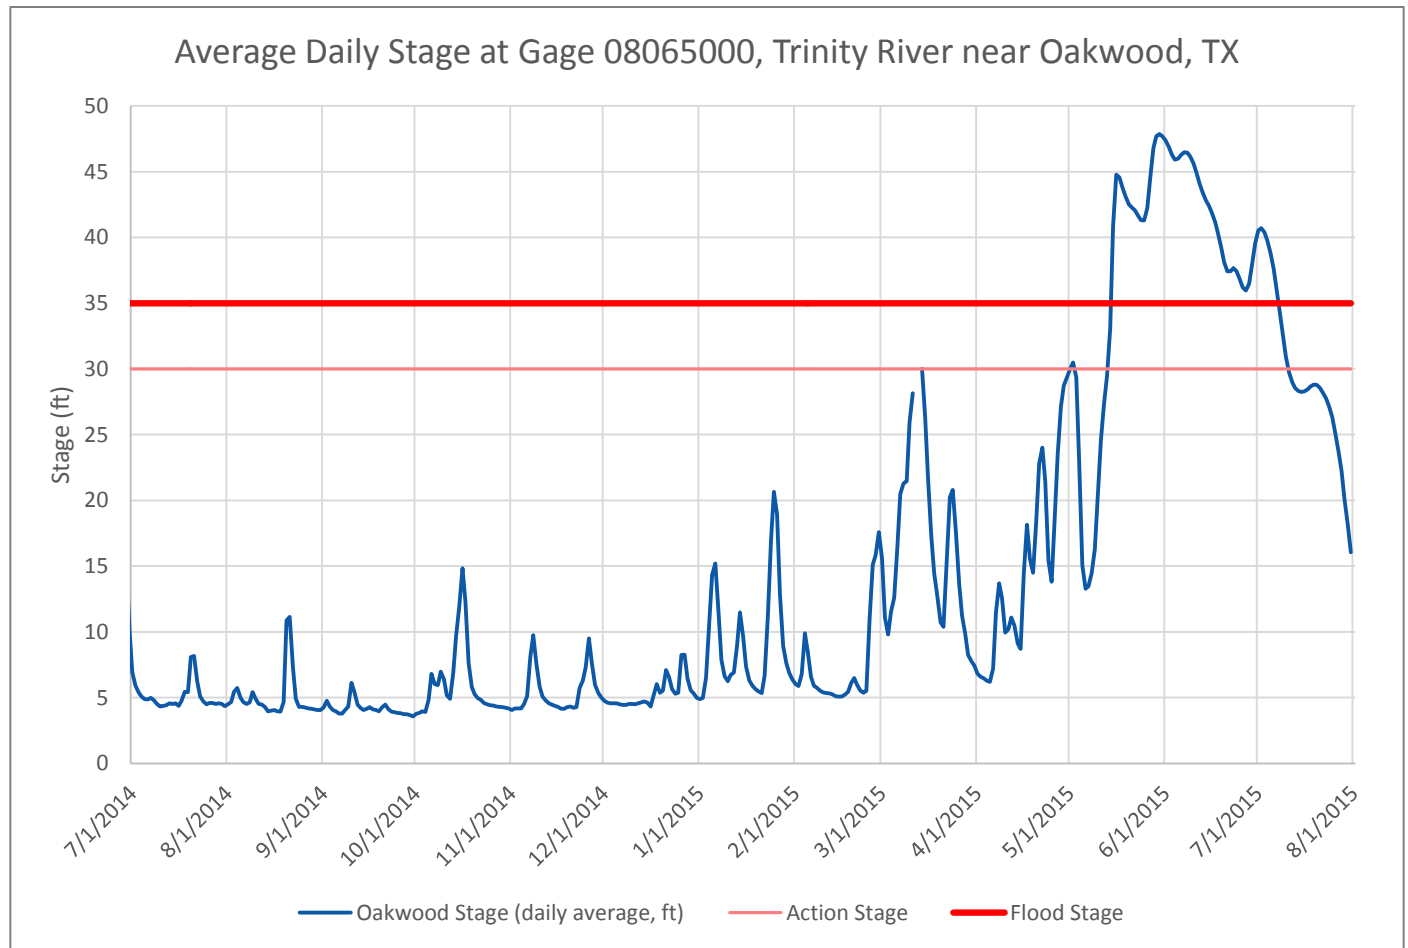
Stage at Oakwood

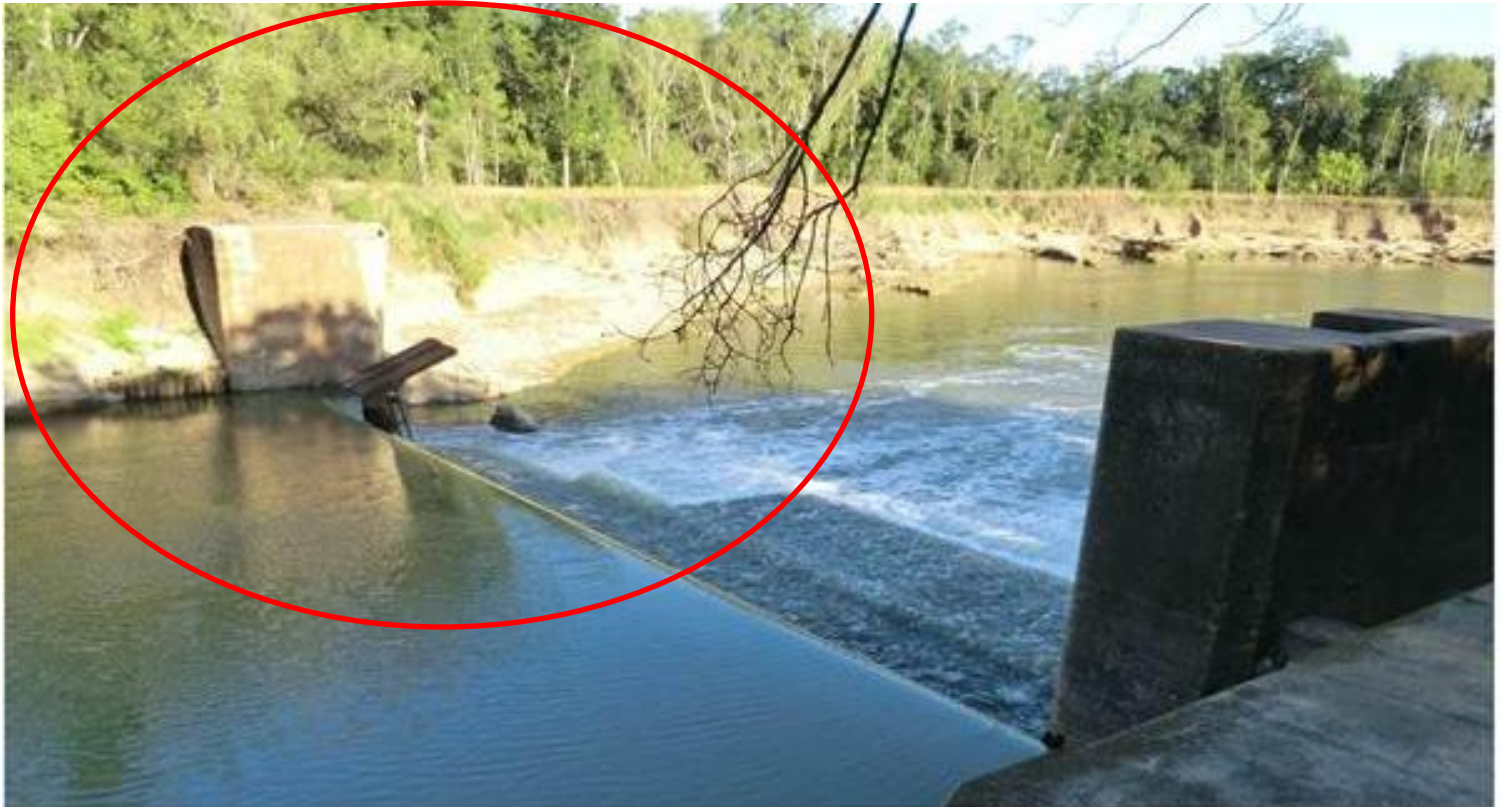
080444 – Relic USACE Lock Monitoring Ongoing Channel Changes

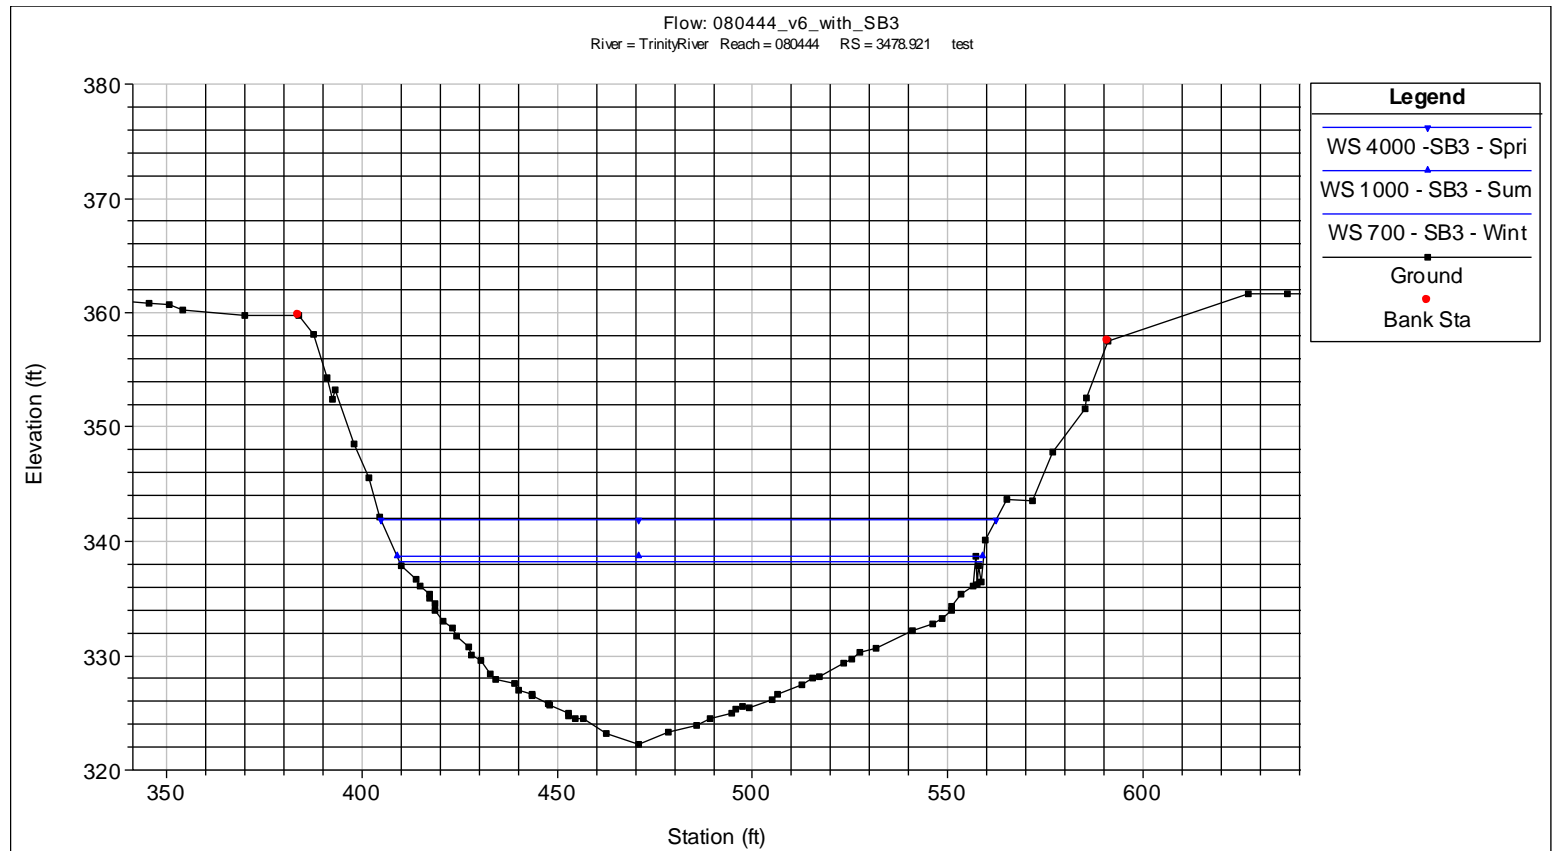
080444 Cross-section 2

HEC-RAS Results at SB3 Pulse Flows

3.71' difference between 4,000 cfs and 700 cfs.

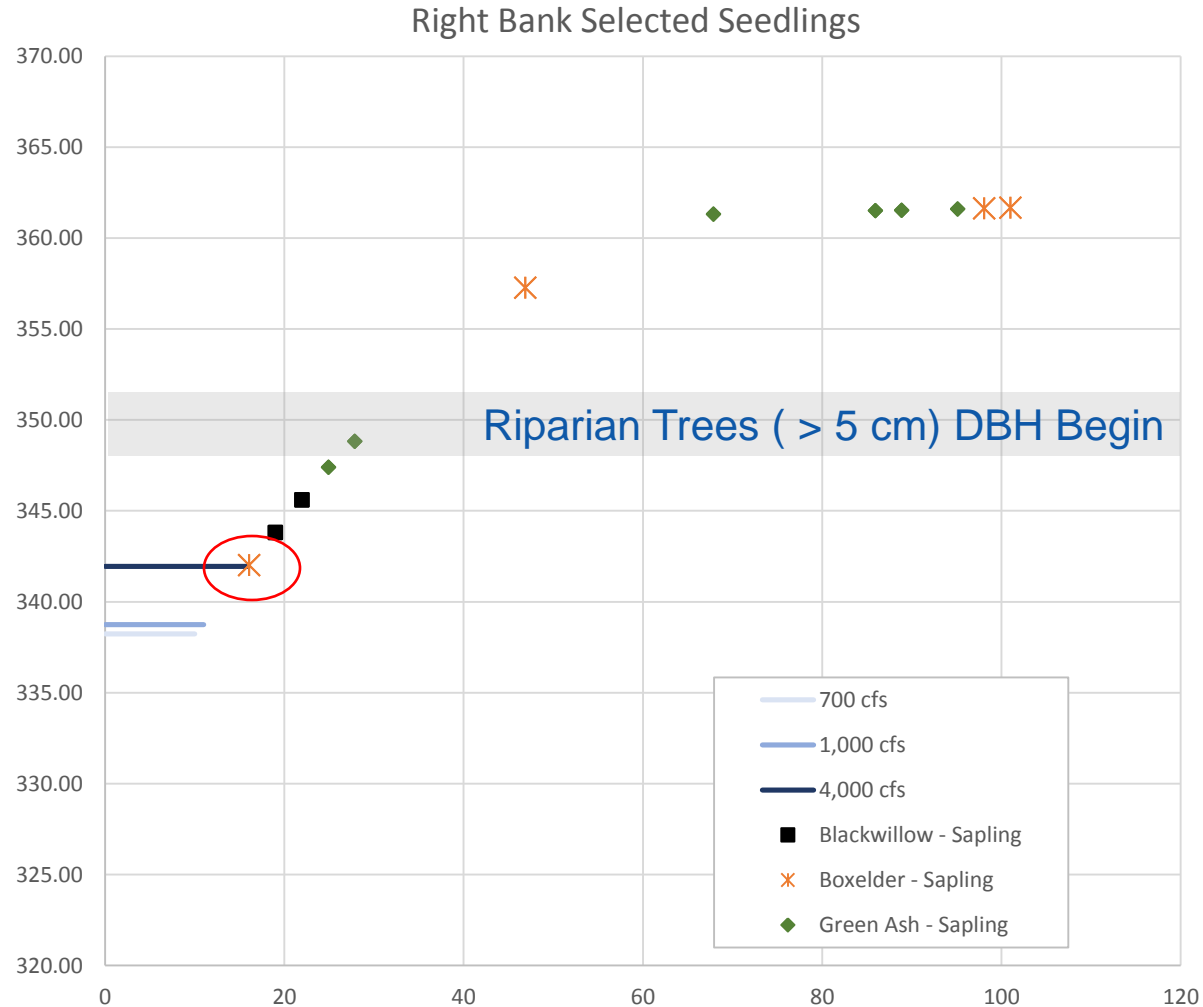
080444 Cross-section 2

Riparian Results* at SB3 Pulse Flows

*Data processed from a previous 2013 study.

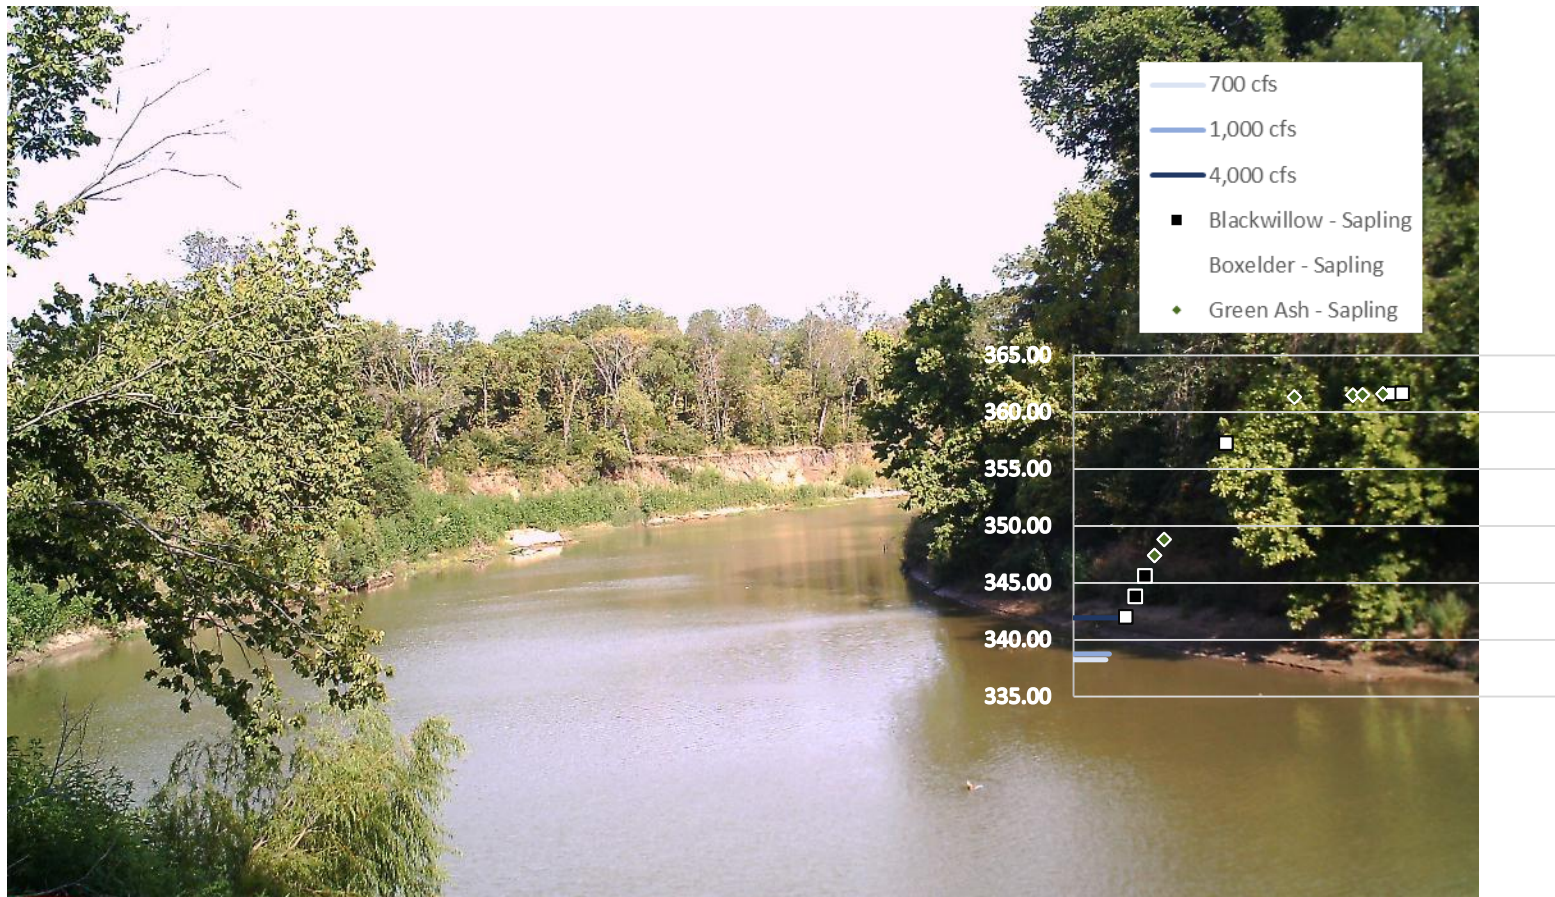
080444 Cross-section 2 – Riparian

~ 700 cfs

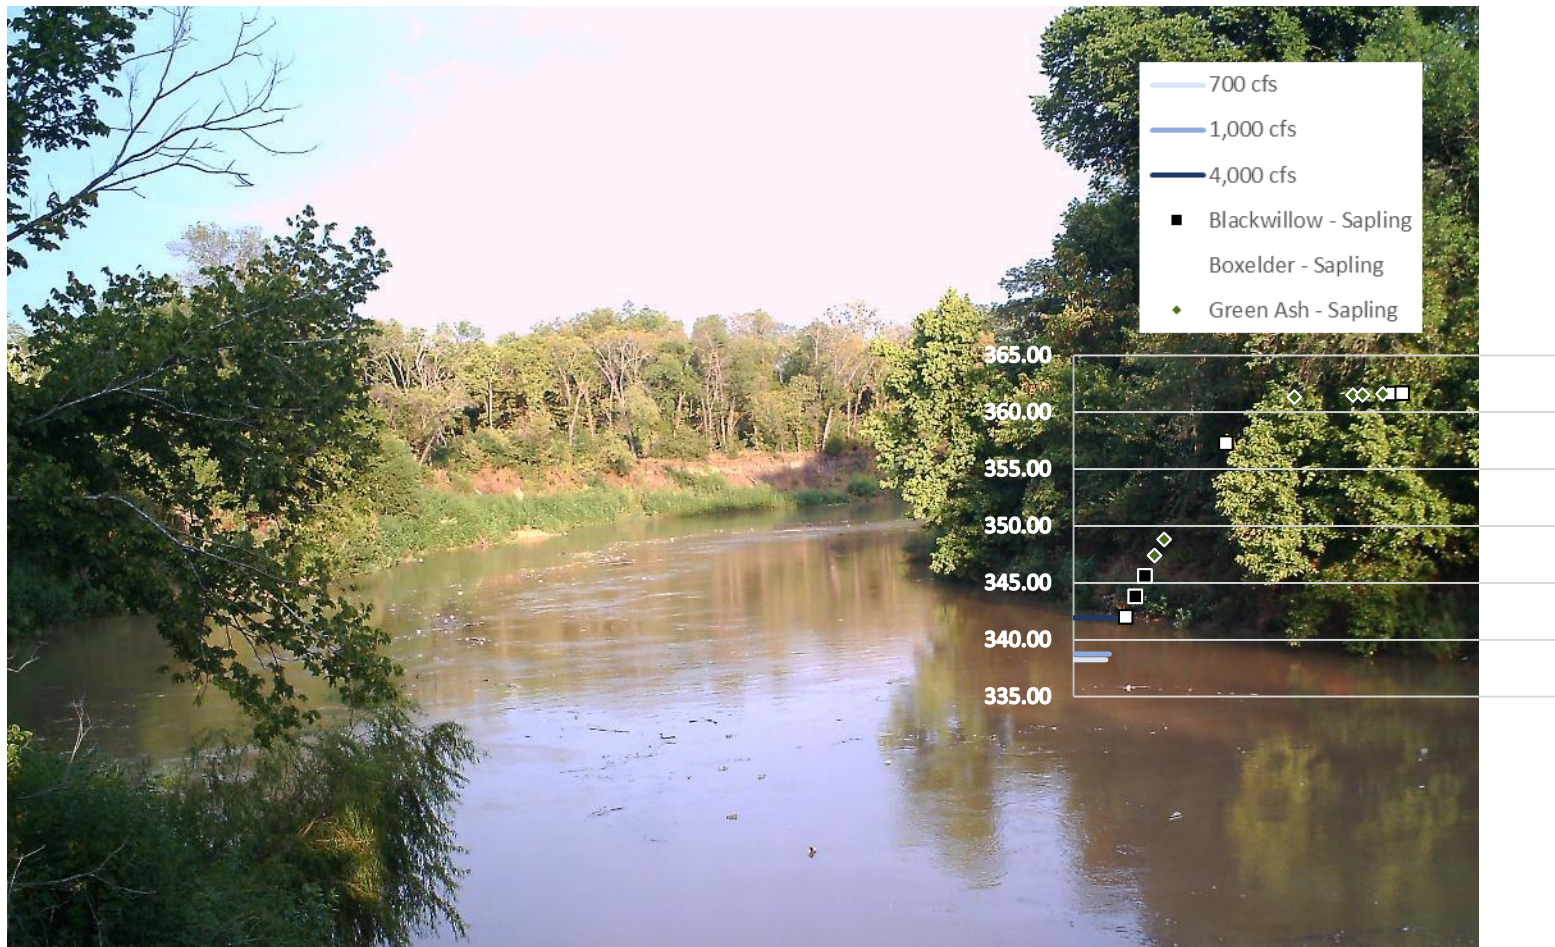
080444 Cross-section 2 – Riparian

~ 5,000 cfs

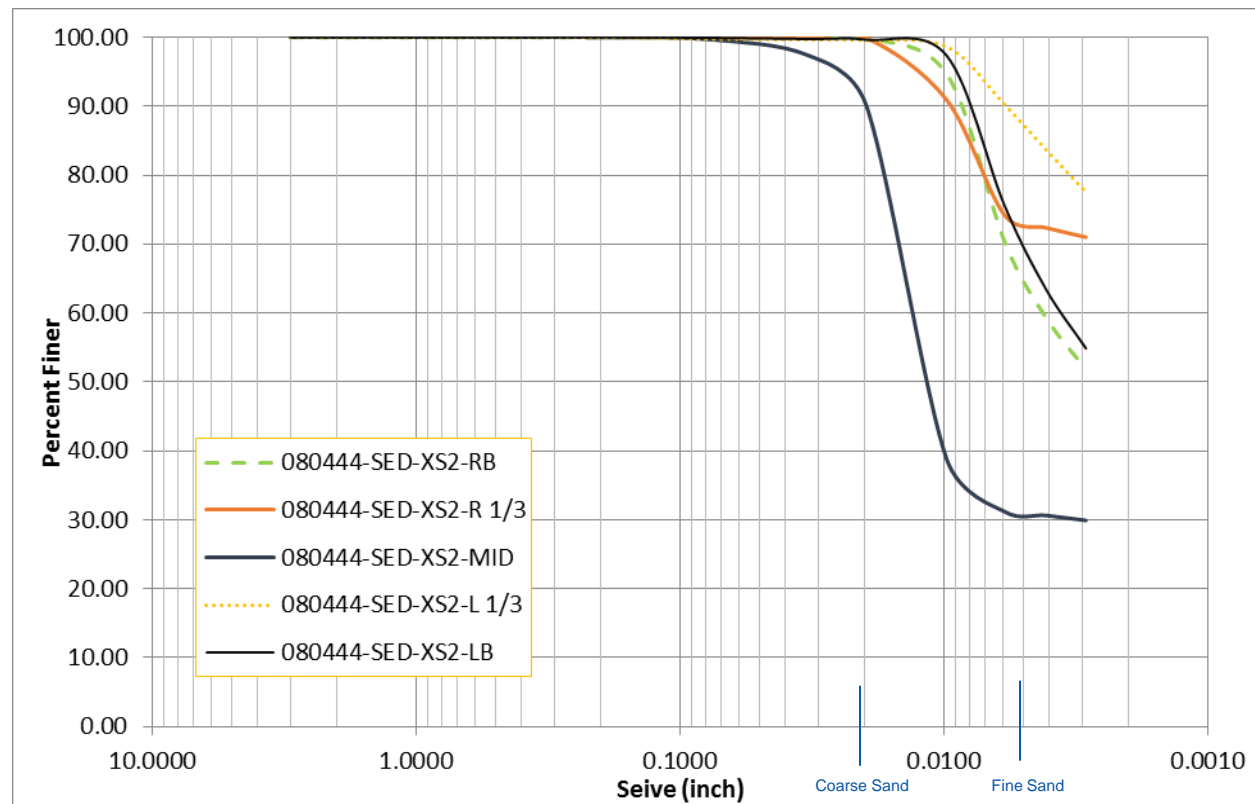
080444 - Sediment Transport Capacity

- Sand is transported at all XSs above 526 cfs, except at XS2 where it is depositing (pool).
- Field collected sediment data agrees

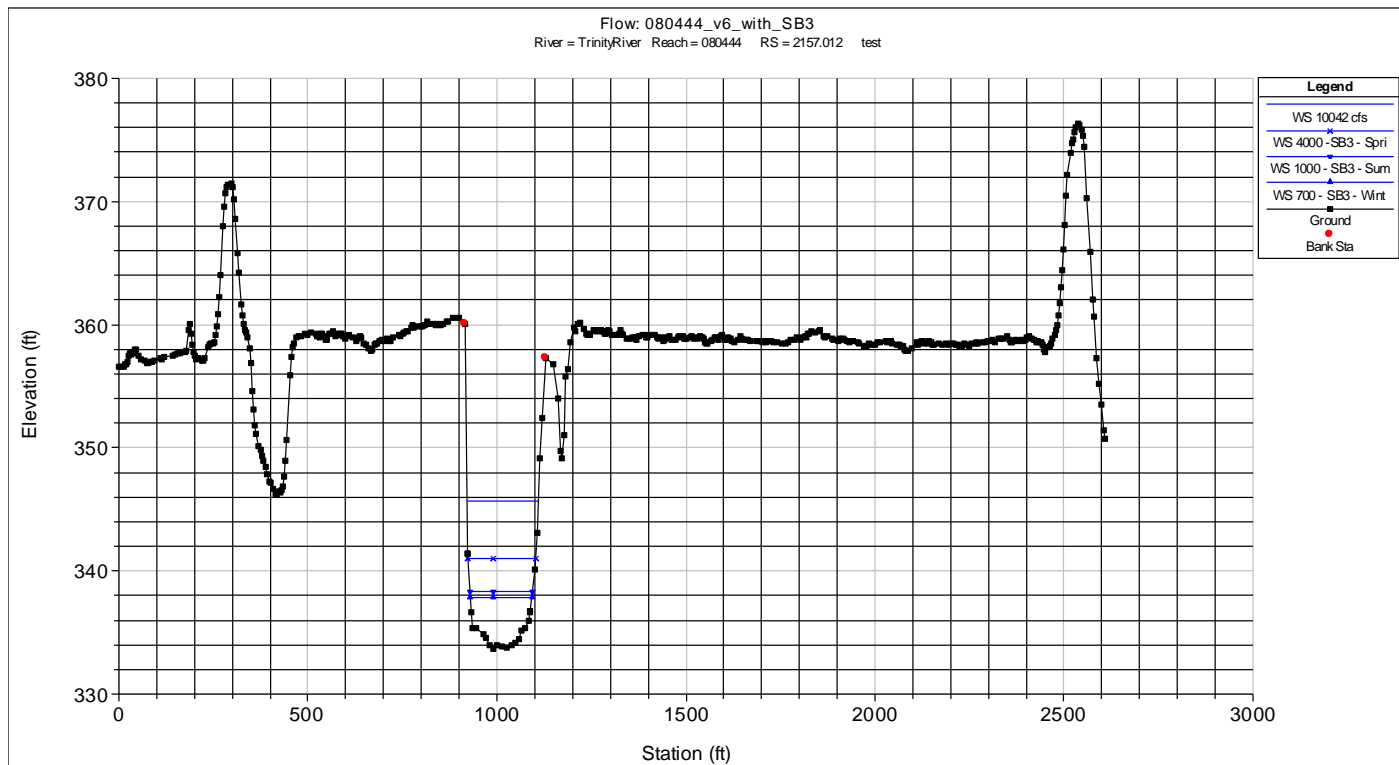
080444 - Overbanking

- No model data in the overbank
- PT retrieved after pulse of $\sim 6,500$ cfs
- Site recon at 10,042 cfs – 15' from TOB at riffle

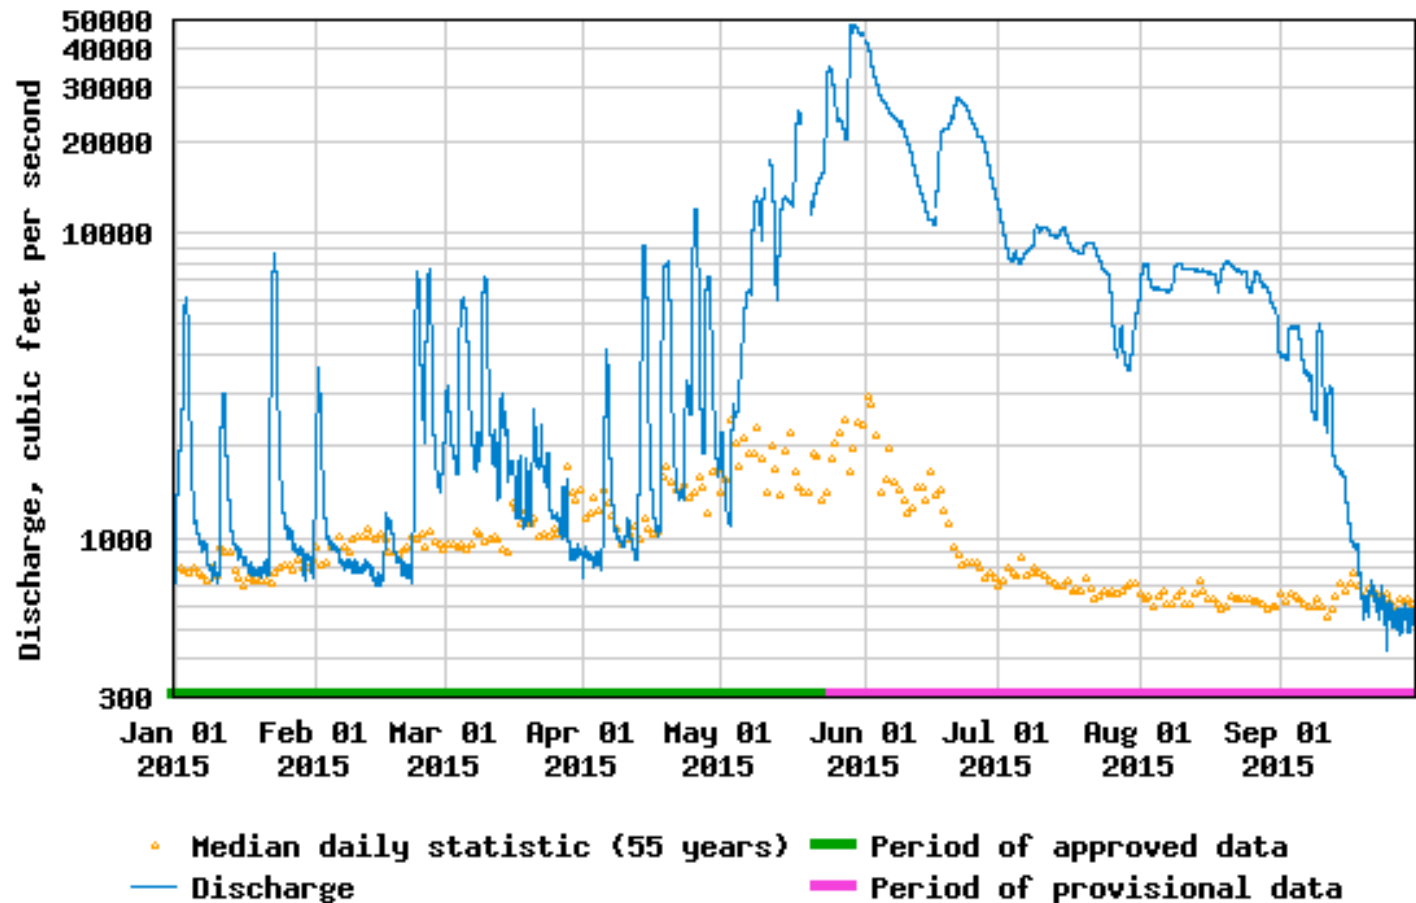
USGS 08057410 Trinity Rv bl Dallas, TX

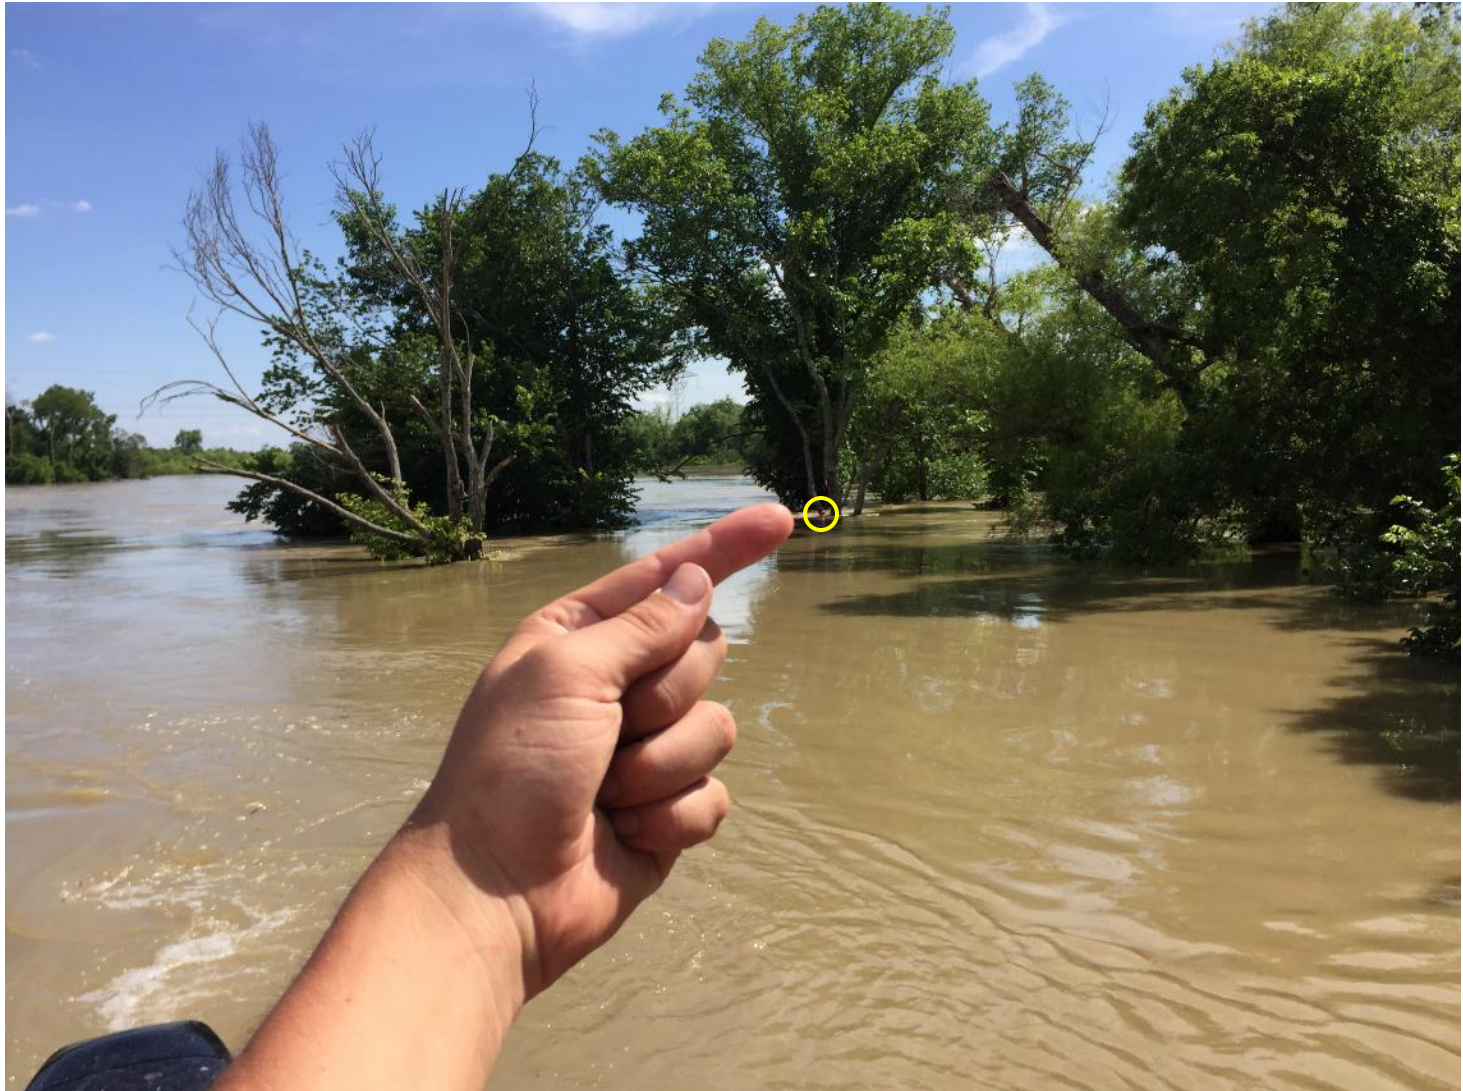
080444 – Overbanking ~ 35,000 cfs

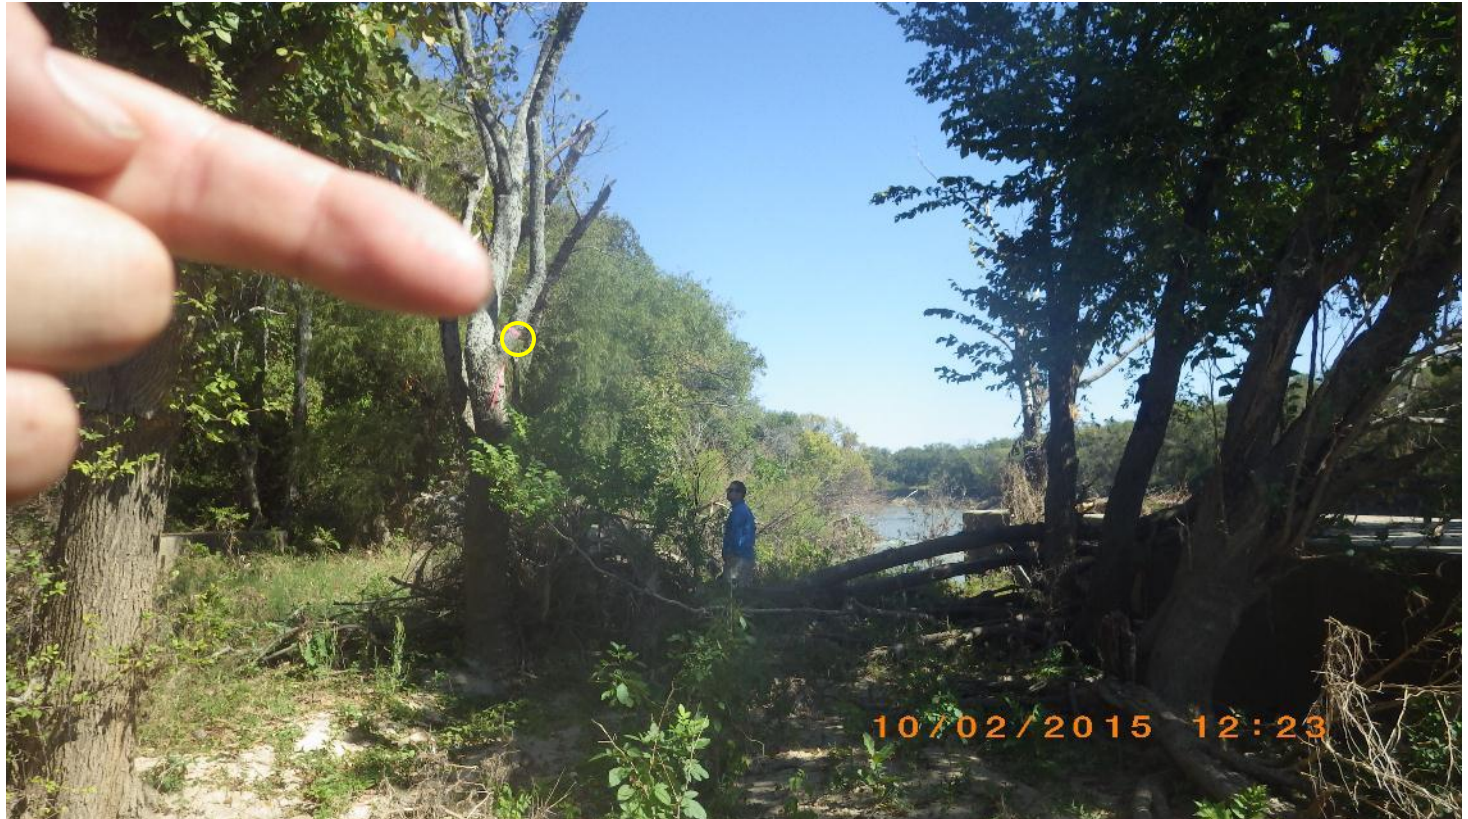
080444 – Overbanking ~ 490 cfs

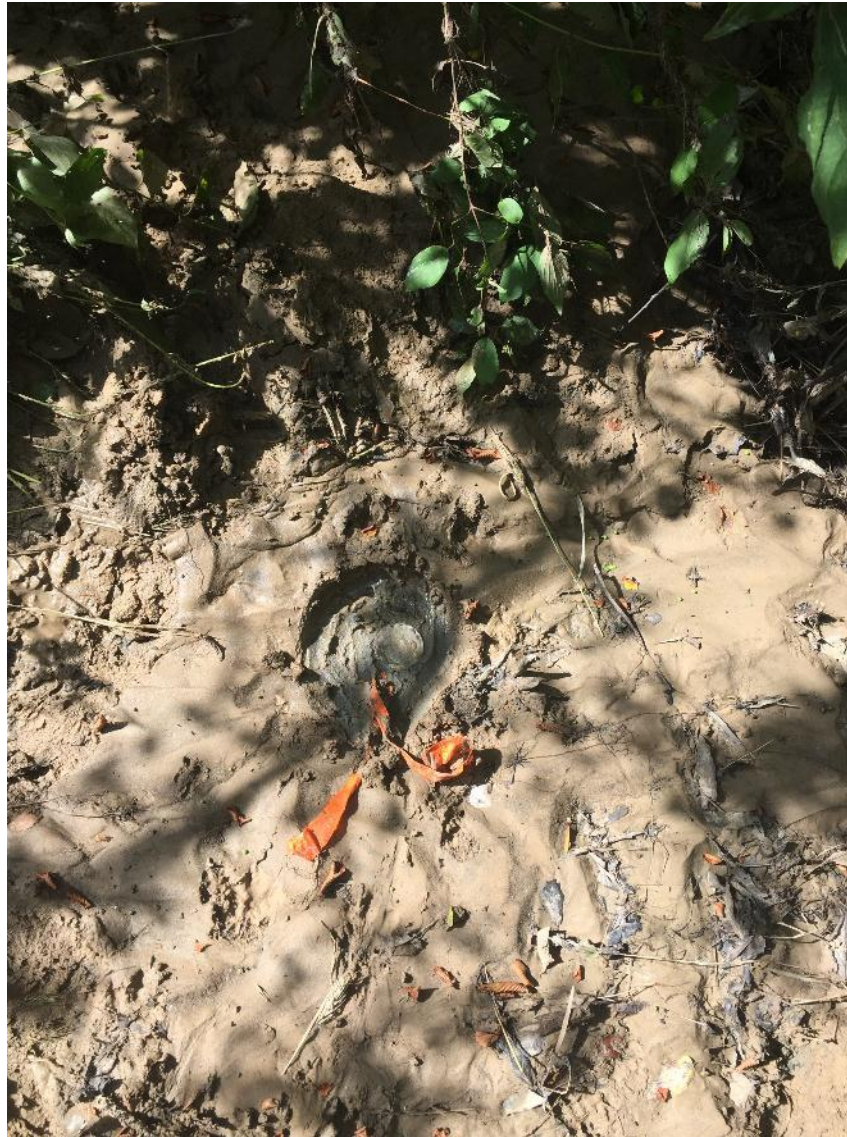
080444 – Overbank Deposition on BM

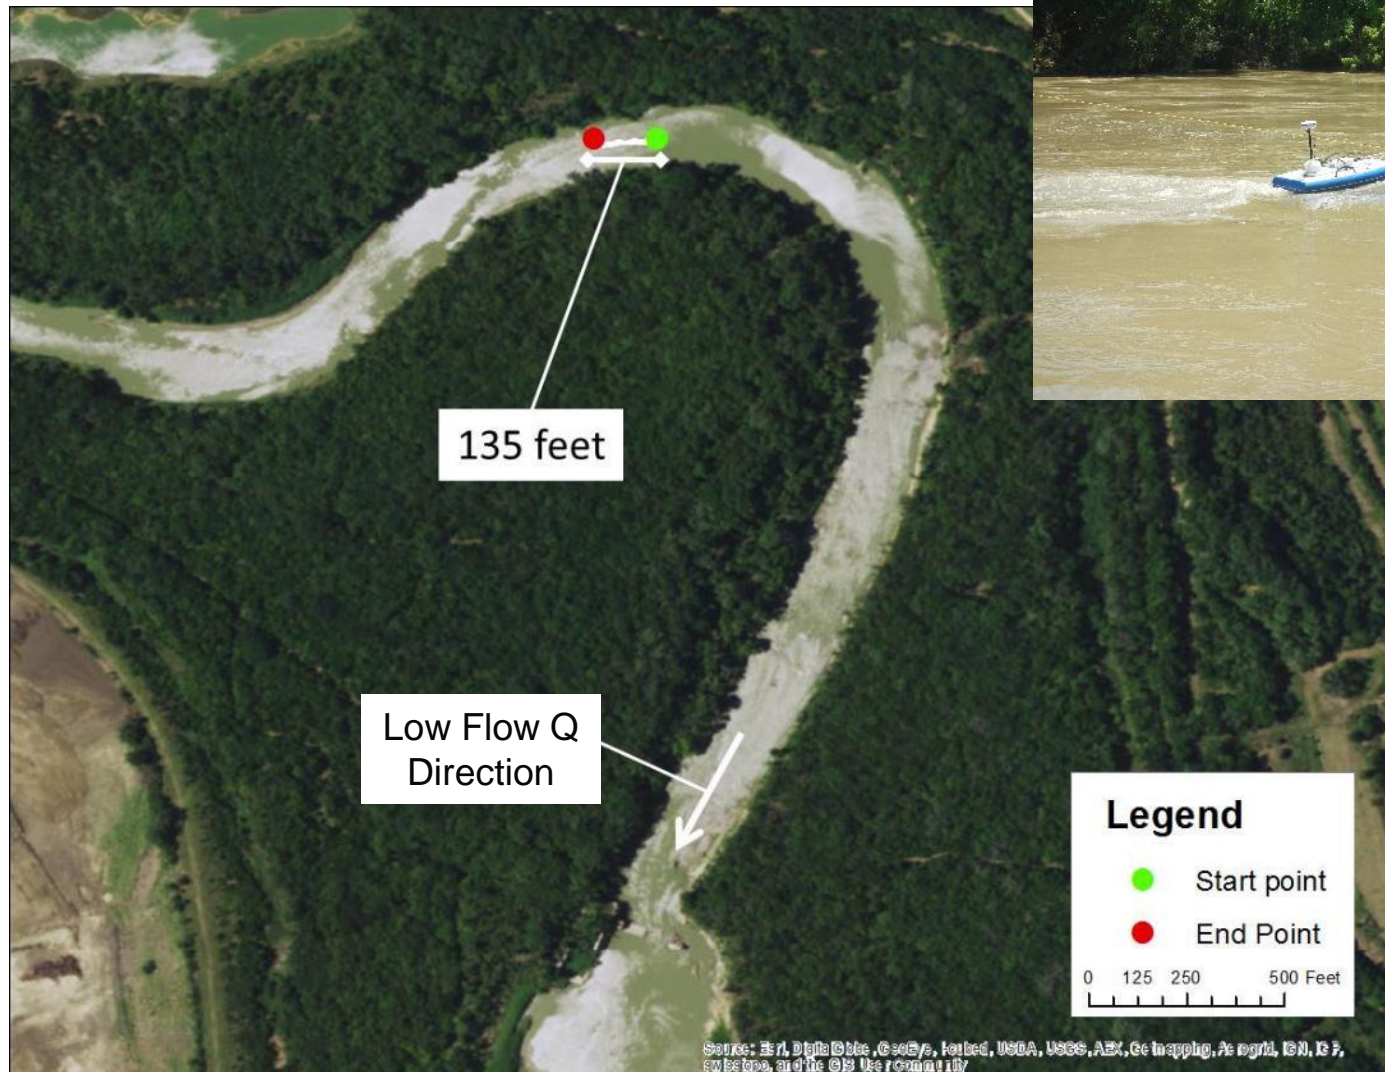
080444 – Moving Bed Measurement

~ 35,000 cfs

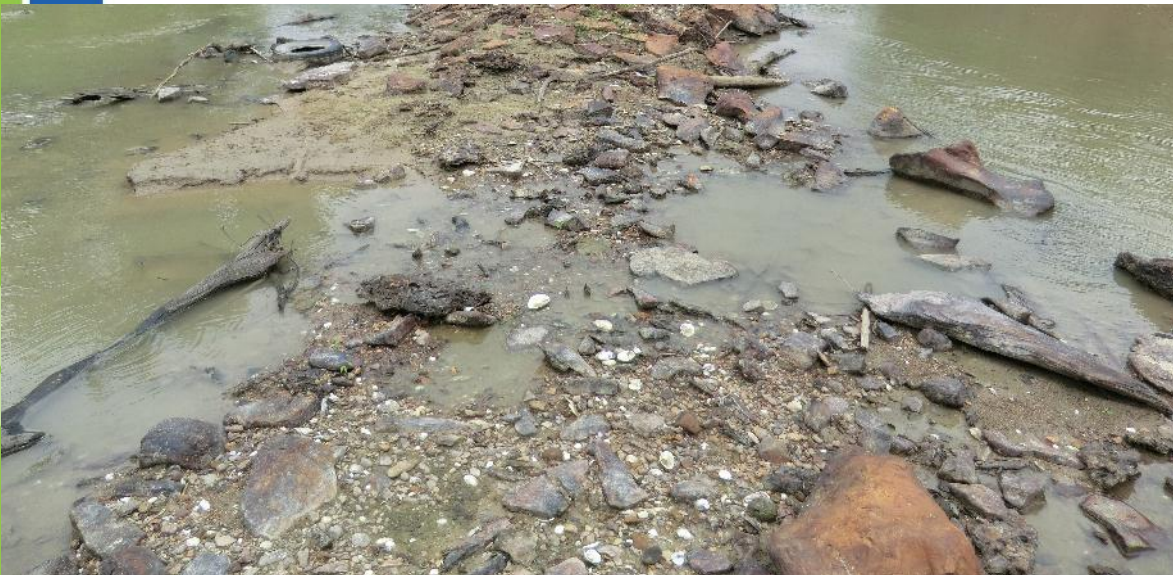
080295 - Sediment

SB3 Flows	Sediment Size Mobilized at 080295_XS_3 (Riffle)
3,000 cfs (Winter)	Small cobble & erosion of compacted clay
7,000 cfs (Spring)	Large cobble & erosion of compacted clay
2,500 cfs (Summer/Fall)	Small cobble & erosion of compacted clay

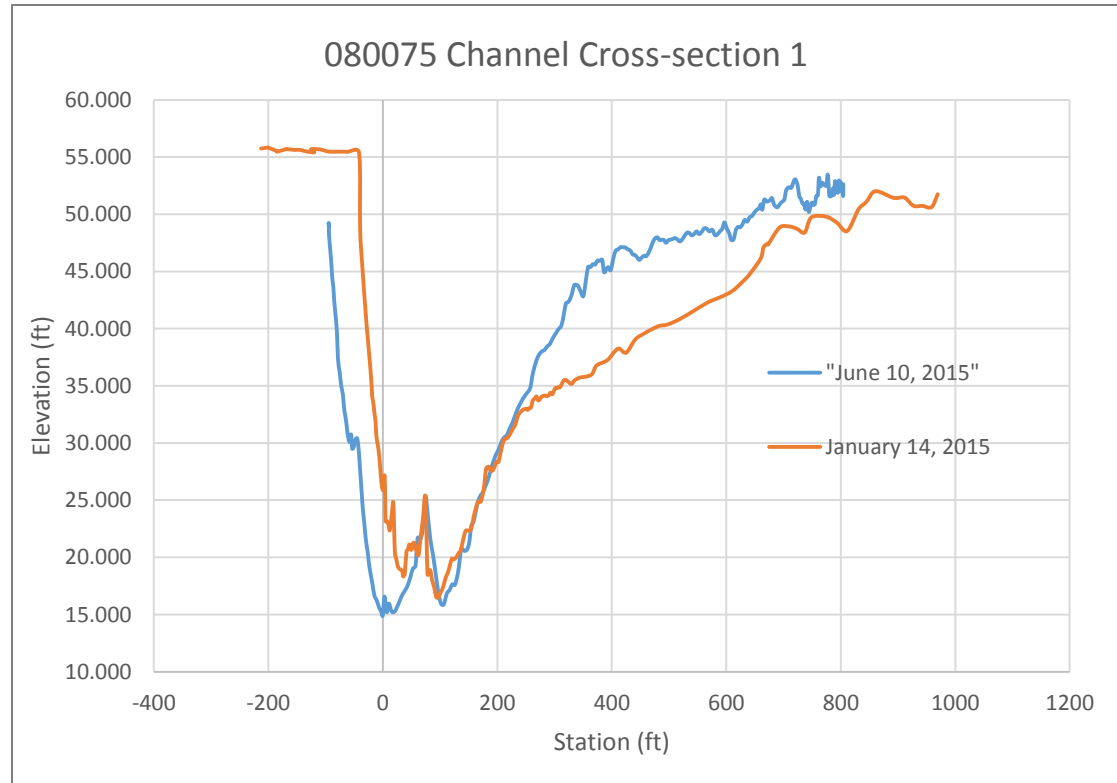
080075 – Cross-section 1 Changes

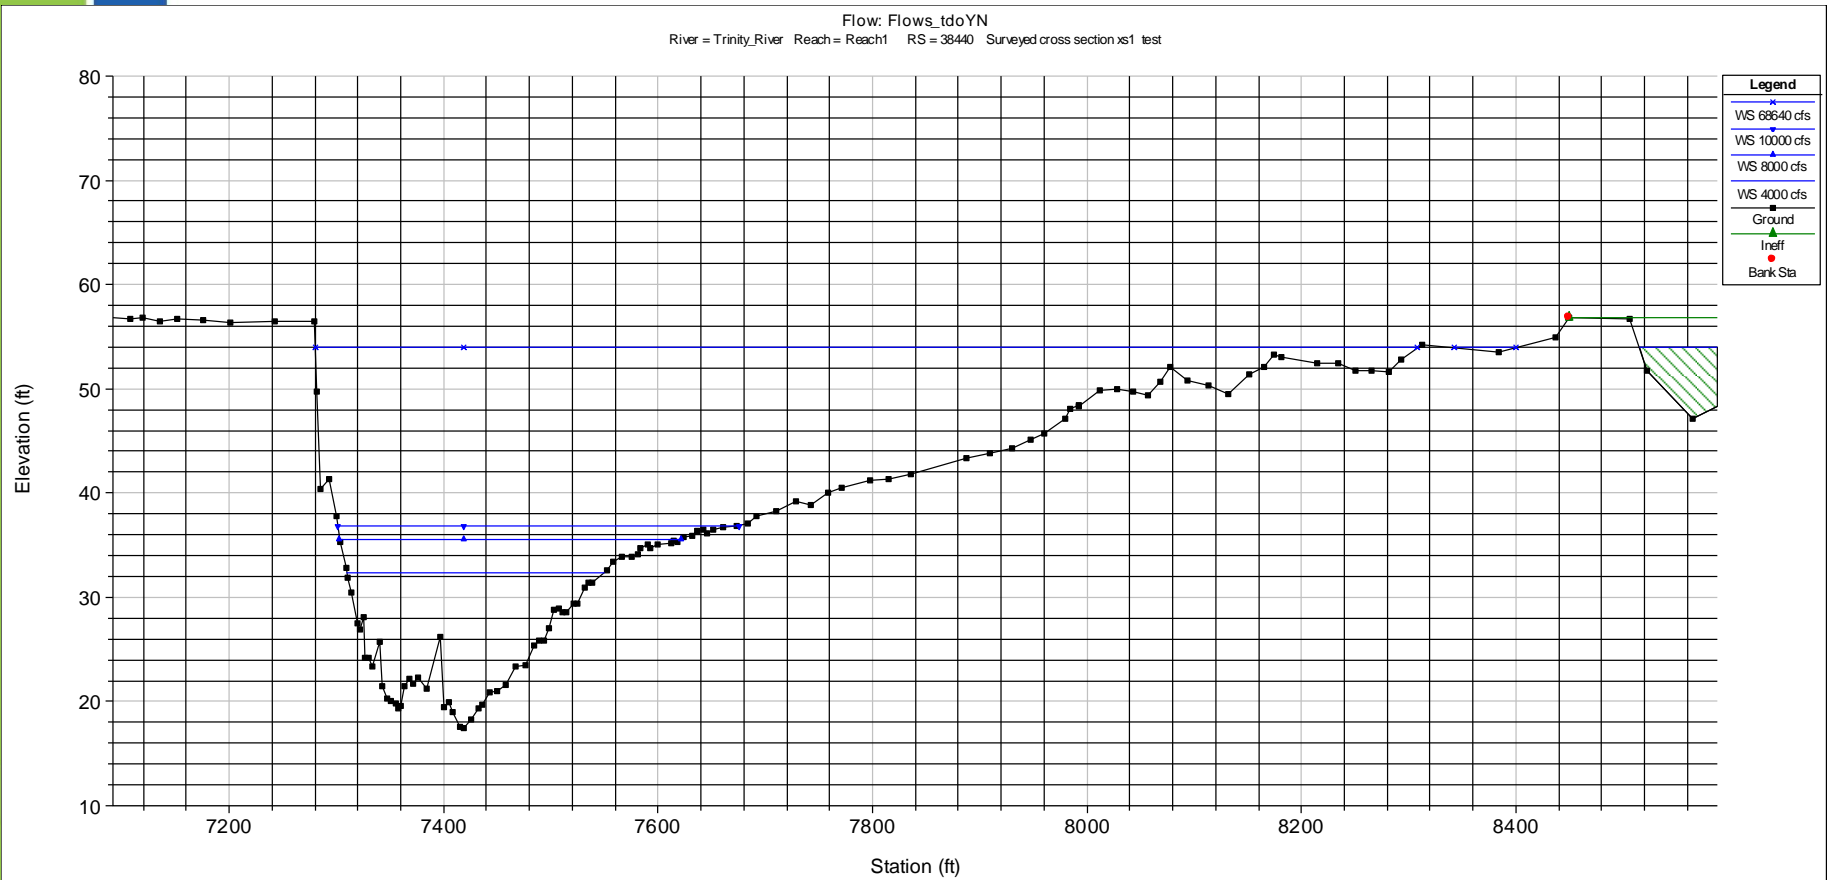
080075 – Cross-section 1

~17' between 10,000 cfs and 68,640 cfs
